CALIFORNIA DIVISION OF MINES AND GEOLOGY

FAULT EVALUATION REPORT FER-143

Kern Front, New Hope, and Premier Faults, Kern County

December 19, 1983

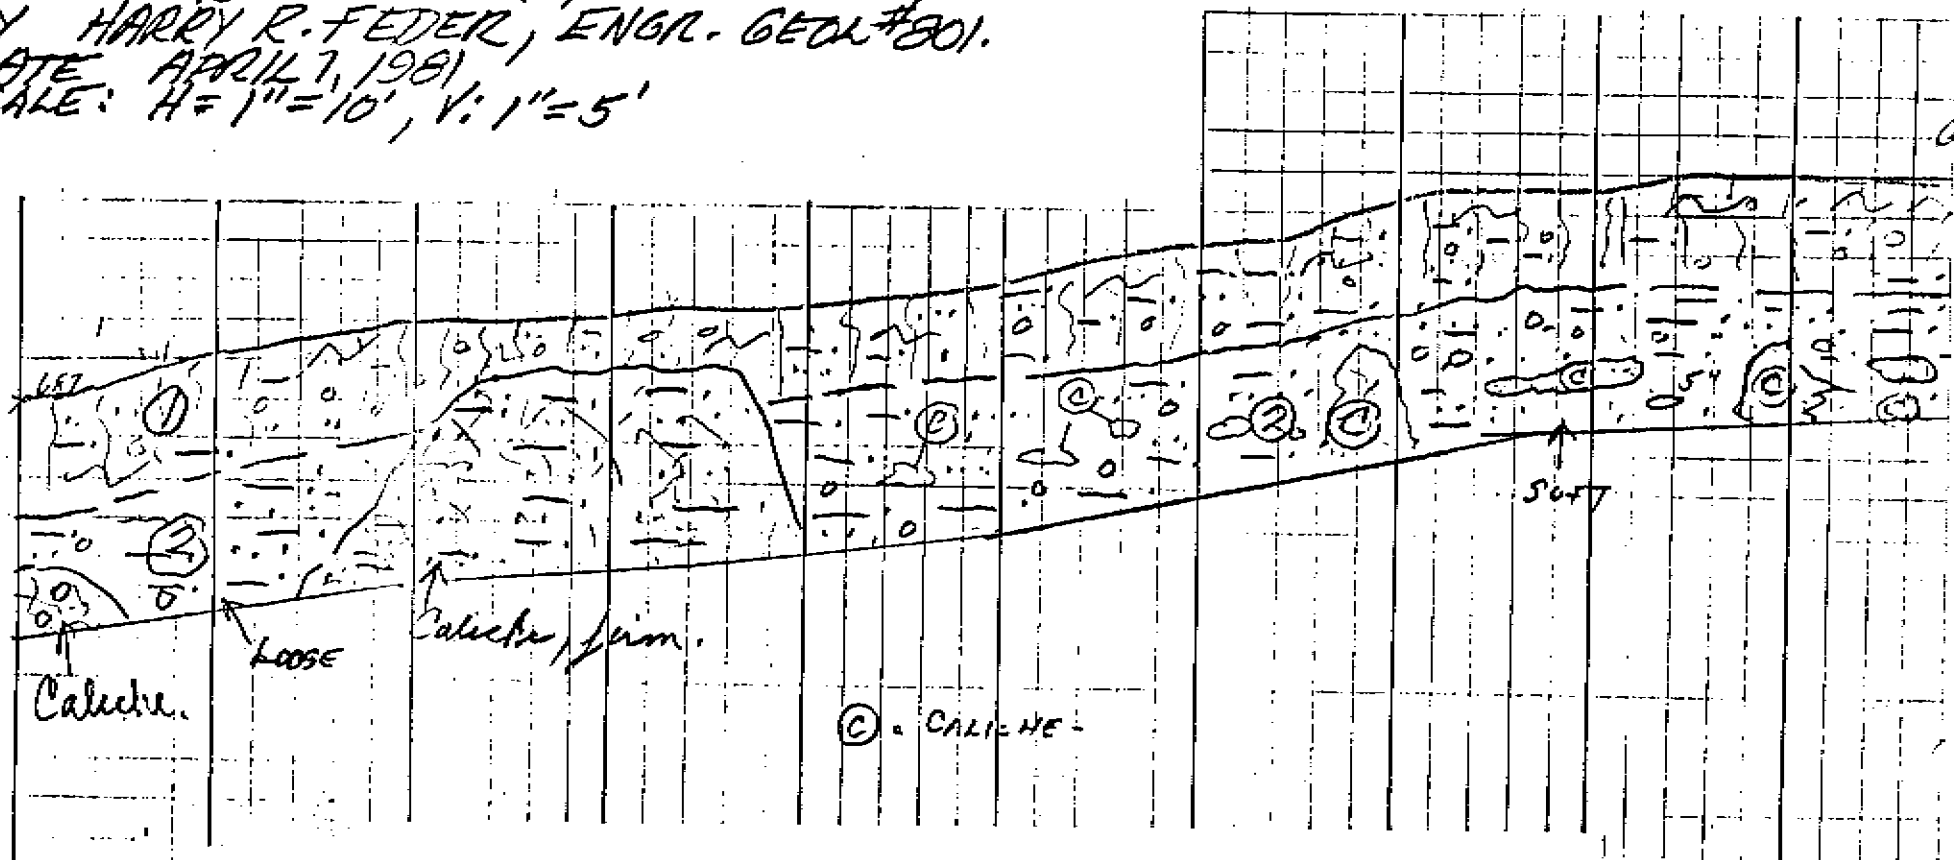
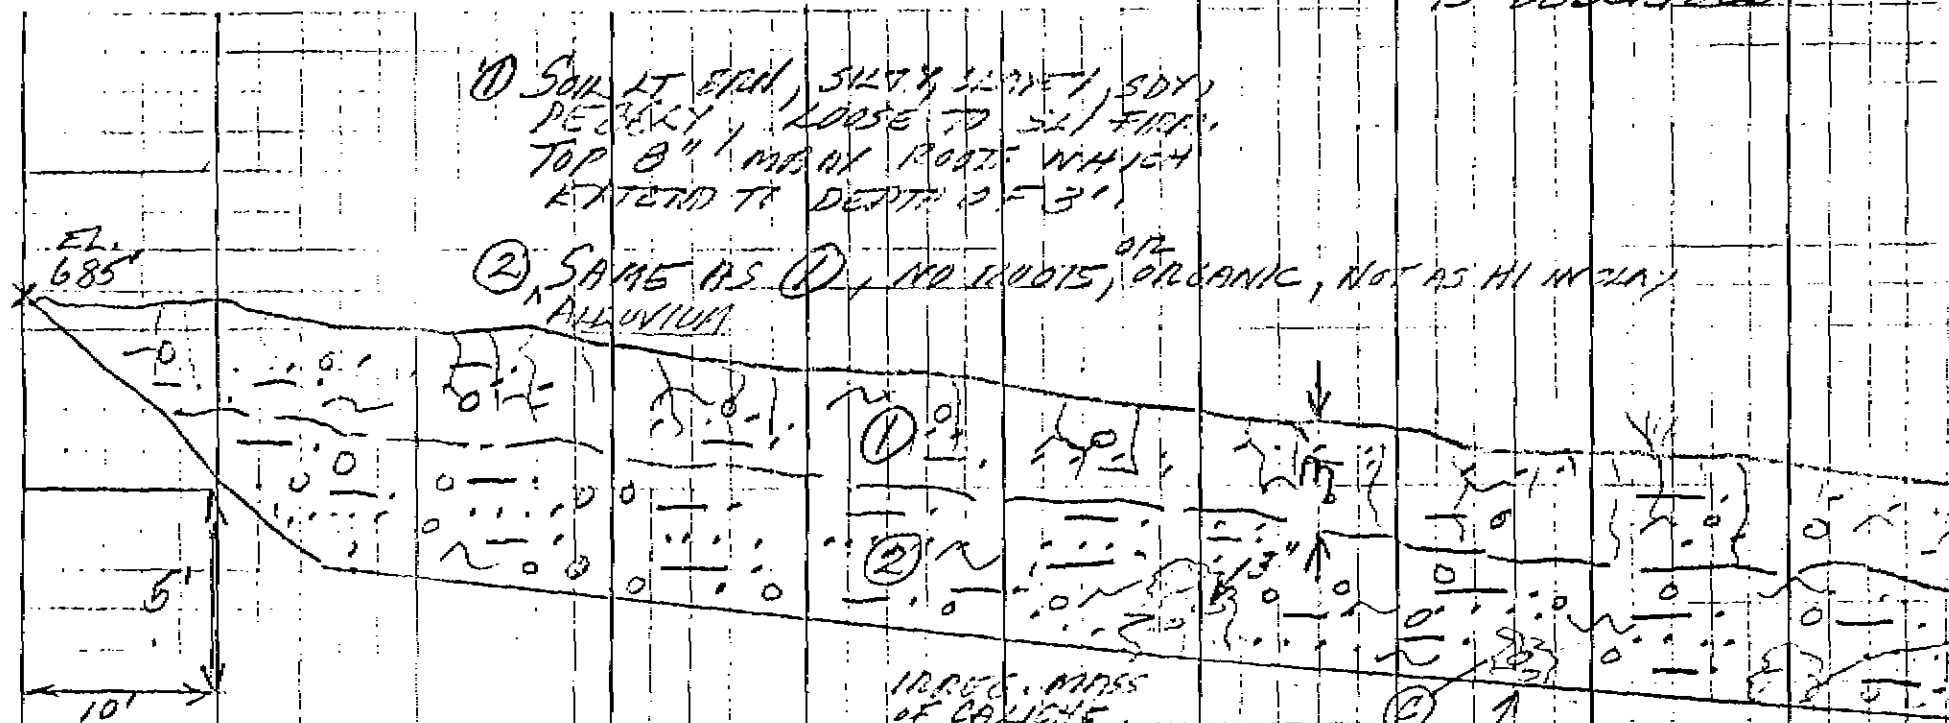
FER-143. Figure 5. Trench log from Feder (1981) showing vertical discontinuities that he did not explain.

Feder (1981 [AP-1404]) conducted a site-specific investigation directed at the hazard of surface-fault rupture (Figure 2B). He trenched across the entire Special Studies Zone and failed to detect any evidence of any fault. However, the trench logs appear somewhat diagrammatic and show several non-horizontal (anomalous) boundaries which bound caliche zones (Figure 5); these boundaries are not described by Feder, and field observations suggest that caliche might locally have concentrated along the "old" fault zone (see below).
